Native Areas: June 2026 Site Visit

Powhatan Metropolitan District

Prepared by: Kristin Oles

Observations from 6/8/2026

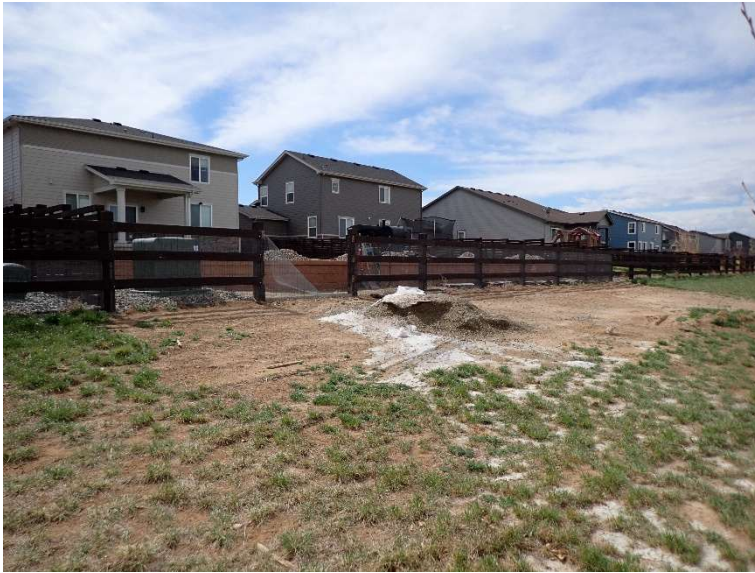
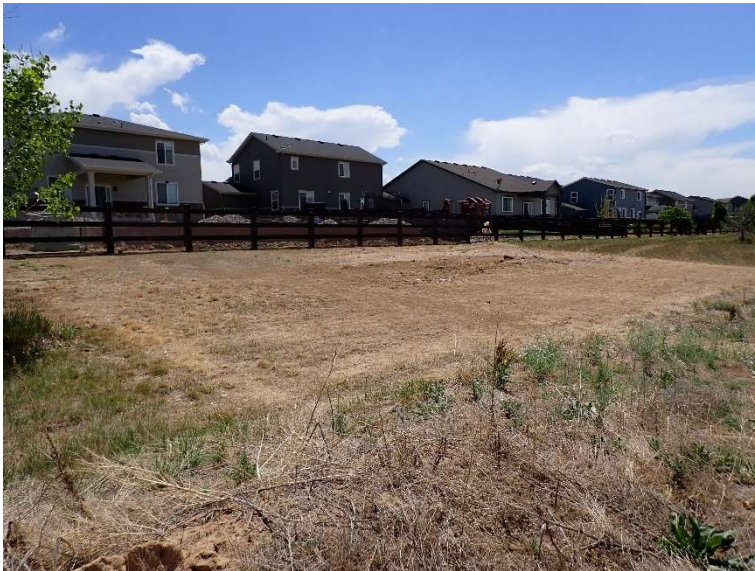
1.) 26839 E. 1<sup>st</sup> Pl. March (top) and June (bottom)

- 1.) 26839 E. 1<sup>st</sup> Pl. – appears to be additional damage, including driving into neighboring field to dump material
- 2.) 26759 E. 1<sup>st</sup> Pl. – same damage as March
- 3.) Dirt dumped in native area, but the source is unclear
- 4.) 26812 E. Byers Ave. – same damage as March  
26822 E. Byers Ave. – adding new grass clippings to existing damage
- 5.) 26832 E. Byers Ave. – adding more material to existing damage

Homeowner fence lines (disturbed bare soil needing smoothing and seed; see photos and numbered map points)

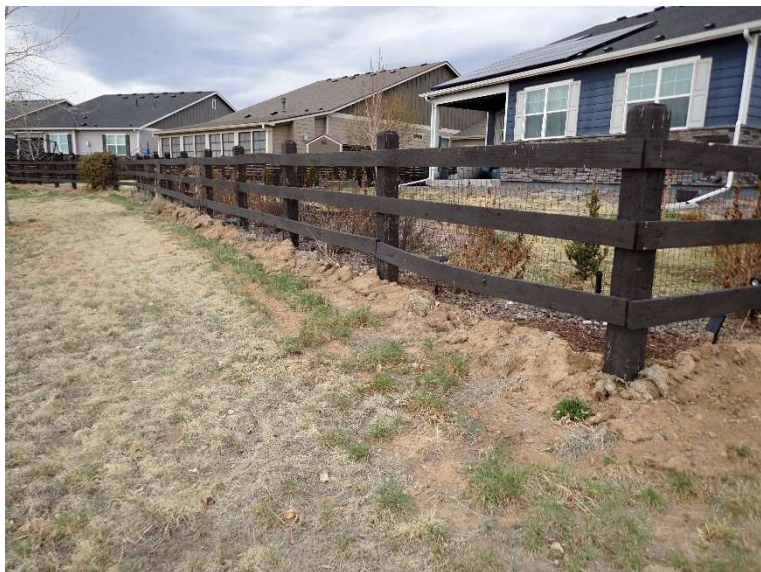
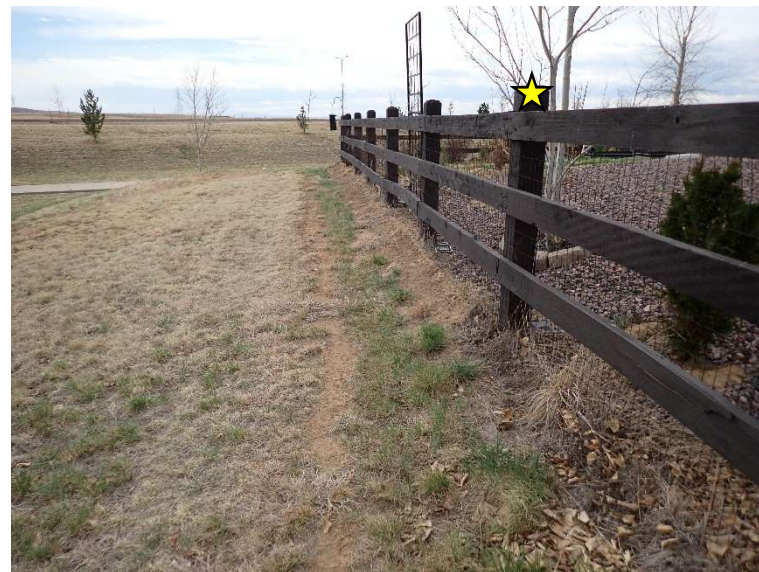
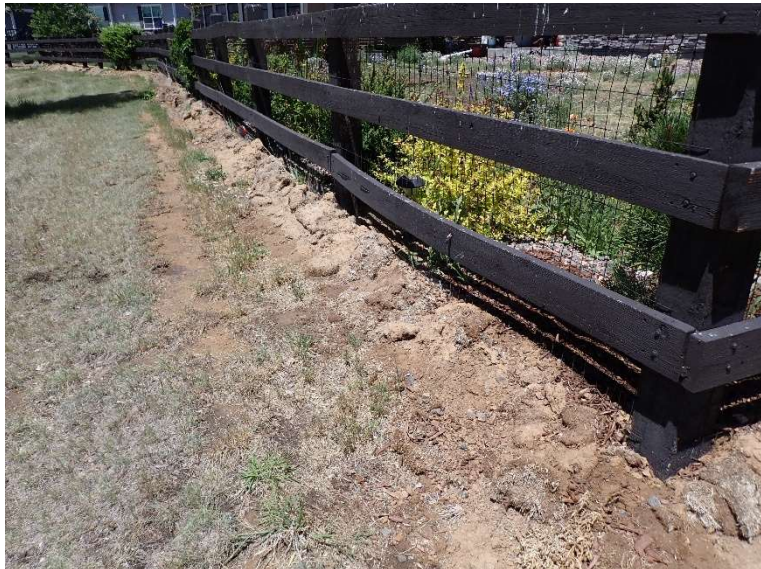
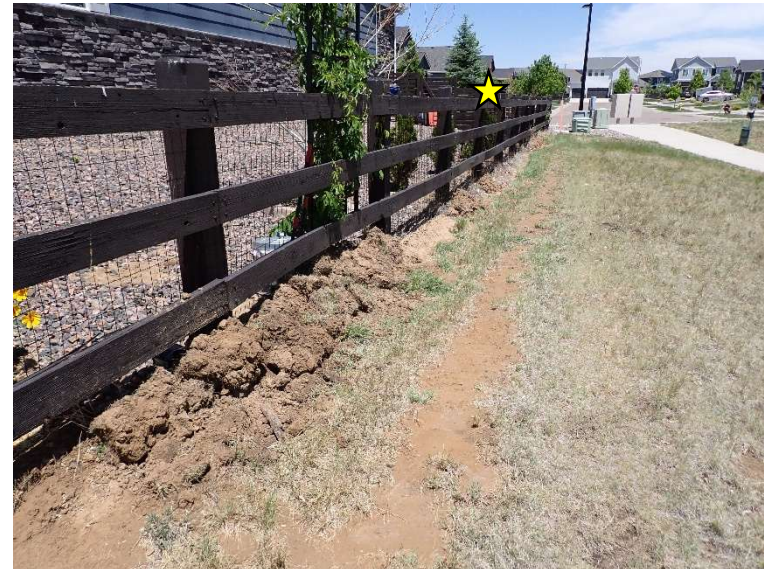
5.) 26832 E. Byers Ave. March (top) and June (bottom)

\*Star marks the same post in both photos

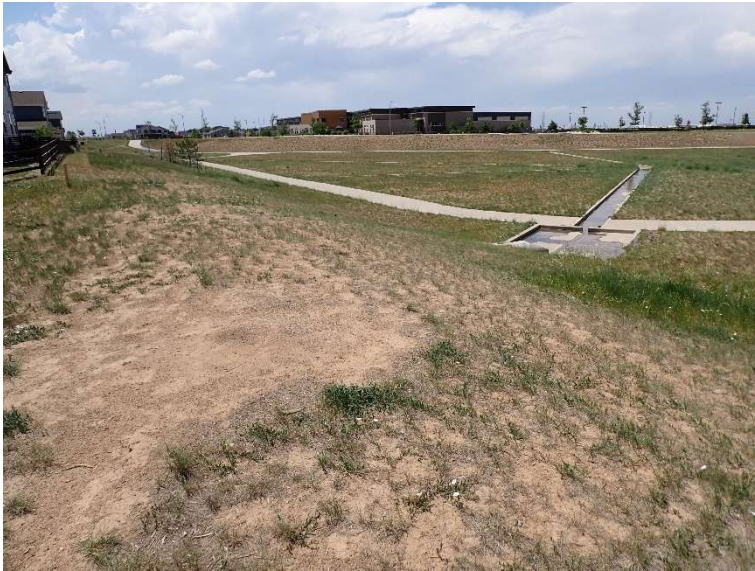
6.) Grass growth in pond

- 6.) It looks like this spot was seeded because grass is beginning to fill in.
- 7.) An additional disturbance area – are there repairs or other work in process for stormwater facilities?
- 8.) Be ready to mow any surviving kochia on this corner in August.
- 9.) Cut back suckers under trees in native.
- 10.) Irrigation box repair area could use some additional seed, but must be the correct seed mix.
